Technical Newsletter

SUBJECT: *TURNTABLE MOTOR BT TINTMASTER*

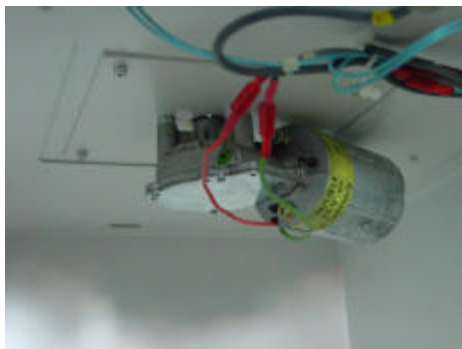
Turntable motor BT16 1860139-SP

PROBLEM: Lifetime of the BT Tintmaster turntable motor is not long enough.

CAUSE: Colorants are very heavy or tixotrop or needs to be stirred more often then the normal setting of each 4 hour, 3 minutes

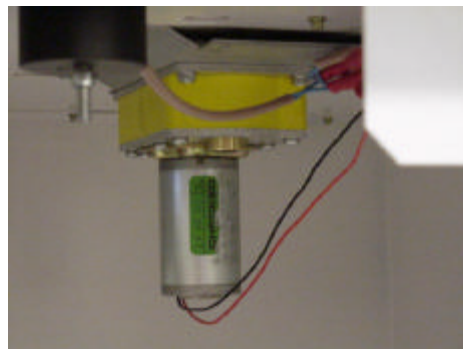
Turntable motor BT24 1861266-SP

SOLUTION: The turntable motor of the BT Tintmaster 24 canisters is stronger and, for the above mentioned cases, will give a longer lifetime.

HOW: Take the normal turntable motor out, including the bracket.
Place the BT24 turntable motor and the new bracket in the same place.
(Part number: Motor 1861266-SP, Bracket 1808485-SP, 4 bolts M5x16)

Adjust the following setting with the Machtune program:
