Technical Newsletter

FLATSCREEN PICTURE IMPROVEMENT

Subject: Hazy letters on your flatscreen display of the dispenser.

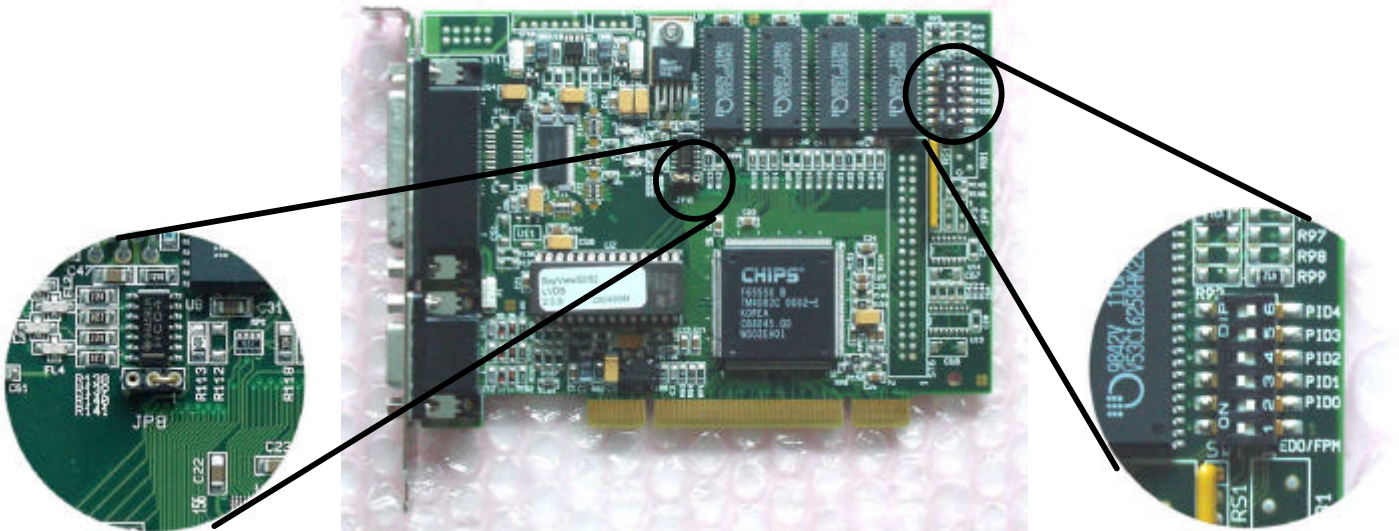
See also the settings of the Dip-Switch in the picture.
The setting must not be changed and should be like in the picture.

Solution: Change JP8 like in the picture below.

How: Switch off the computer and take the cover off.
Take the card out of the computer and look at the JP8
If it is not in the position like in the picture then change it over.
If the jumper is in the position like in the picture then it is set optimal.
